TECHNICAL BULLETIN

Ref. No. T9106TD

TBR Sidewall Repair and Identification

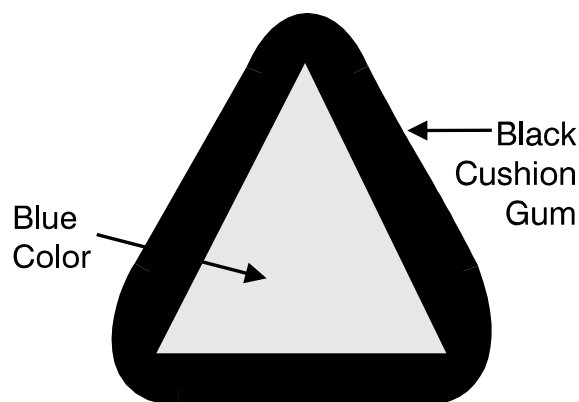
Sample Triangular
Identification Patch

Note: Actual Size

In October 1990, the CVSA agreed to accept the use of a blue triangular identification adjacent to a sidewall repair bulge. A vehicle will not be placed out of service if a tire repair bulge is 3/8" or less in height and is identified with an adjacent blue triangle. The retread and repair industry will be incorporating these identification patches into their sidewall repair procedures.
